## Influence of Abnormal Ultrasonic signal on the surface of Zr-4 pipe

**Abstract.** In this paper, the ultrasonic testing, metallographic observation (MO), and electron microscopy observation (ETO) were conducted to investigate characteristics of ultrasonic signal on the surface of Zr-4 pipe, and then the reason of the crack were modeled by the finite element analysis (FEA). The results showed that the crack on the wall of the inner surface and polishing trace on the outside surface of the Zr-4 finished pipe were leading in the abnormal ultrasonic signal. The crack on the wall of the inner surface were madding up the intermediate pipe of Zr-4 tube. Theoretical analysis is consistent with practice on the crack model for Zr-4 tube by FEA. As seen that the results and FEA model were an efficient quantitative tool to product guidance.

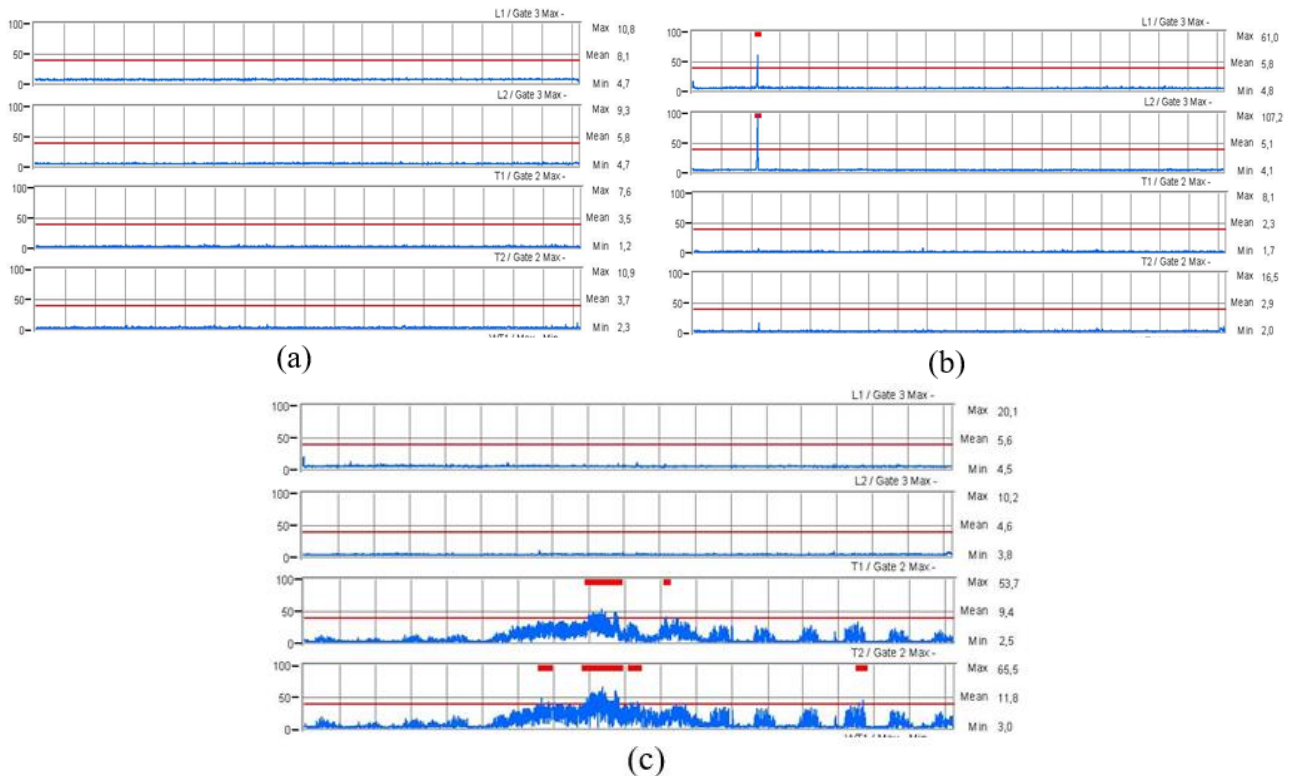
**Figure 1.** Ultrasonic records (a) normal record (b) Record abnormal signal pipes of longitudinal damage channels (c) Record the continuous abnormal signal pipe of the transverse damage channel

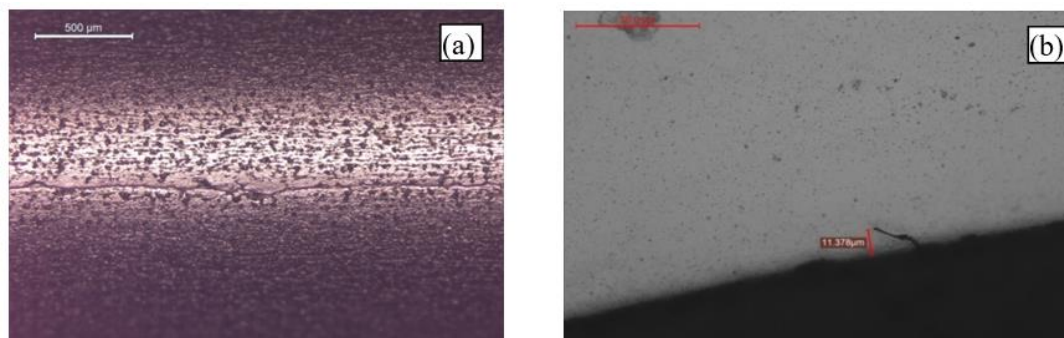
Internal surface defect morphology of Zr-4 alloy pipe on longitudinal damage channels are showed in the figure 2. It is really like a crack as internal surface topography as far as from the figure 2 (a). Meanwhile It is really like a oblique crack far more than 45 degree and 11 $\mu$ m long as internal surface profile topography as far as from the figure 2 (b).

**Figure 2.** Internal surface defect morphology of Zr-4 alloy pipe (a) Internal surface topography (b) Profile topography

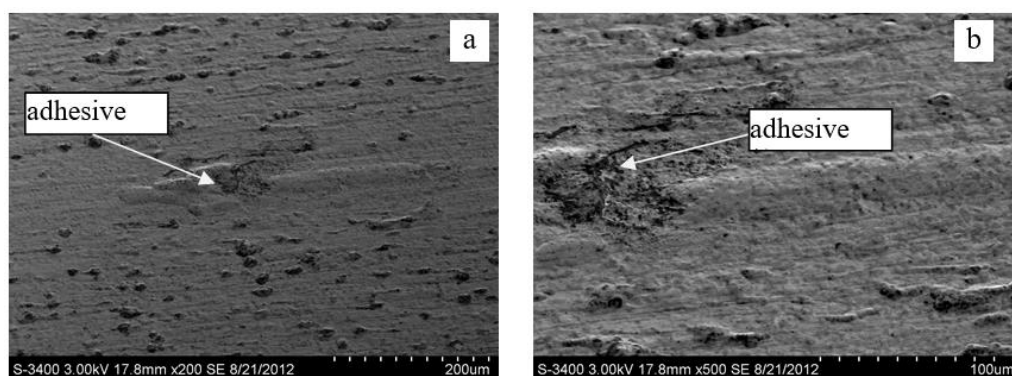
Fig. 3 shows the observation results of typical defect morphology in the inner wall of zR-4 alloy tube billet in the signal area of excessive standard of longitudinal damage channels. The inner wall of ZR-4 alloy tube billet is mainly composed of bonding defects, and the local area of bonding is large. The specific morphology is shown in FIG. 3 (a) and (b). The folding defects of Zr-4 alloy products are selected and peeled along the defect cracks. The specific morphology is shown in Figure 4. As can be seen from Figure 4, the finished Zr-4 alloy sample can be divided into three morphologies, namely, the inner surface of the finished pipe, the folded surface and the newly peeled surface, after being peeled along the folded surface. The morphology of the new peel surface is obviously different from that of the folded surface. Because the Zr alloy is a ductile material, the new peel surface will have typical dimple morphology along the peel direction, while the morphology of the folded defect is basically consistent with that of the inner wall of the tube billet.

**Figure 3.** Morphological observation of typical defects in the inner wall of Zr-4 alloy tube billet in the signal area of overbid

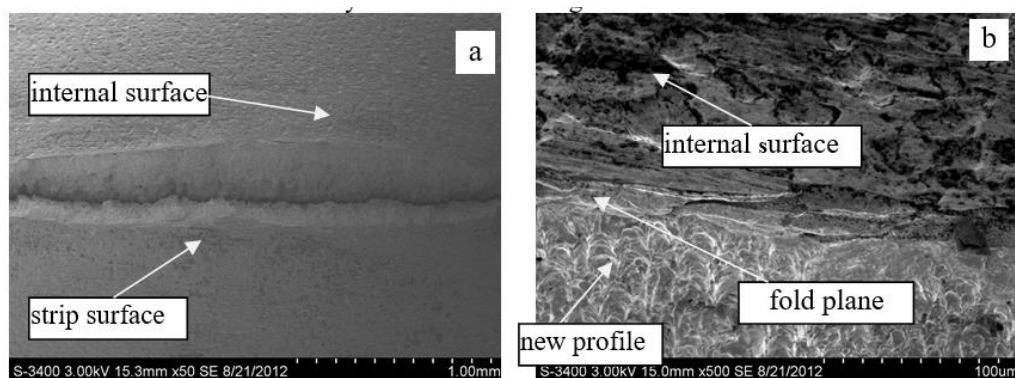
**Figure 4.** Typical morphology of the inner surface of Zr-4 finished pipe (a) Un-finished pipe (b) finished pipe

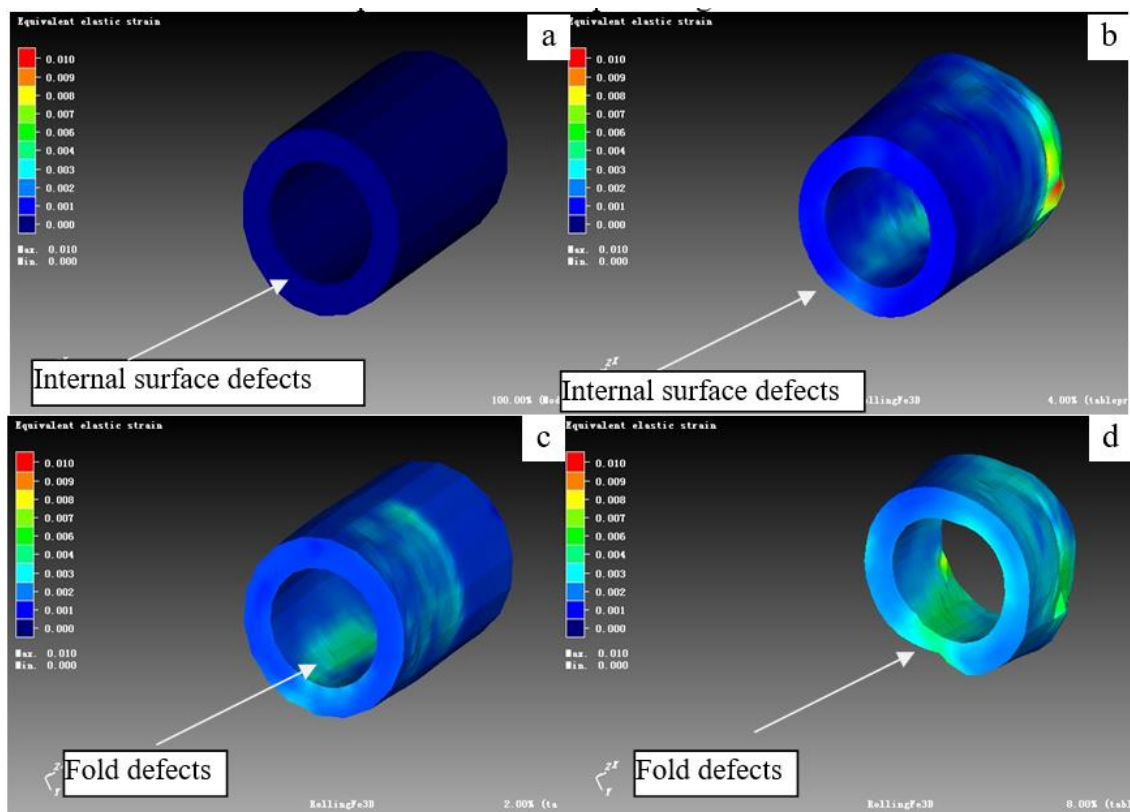
The FEM model formed by the inner wall folding of Zr-4 alloy pipe is established by using the FEM theory, and the specific formation process is shown in Figure 5. In the rolling process of the pipe, due to insufficient lubrication between the inner wall of the tube billet and the core head, the friction force in the rolling process of the pipe is large, so that the local area of the rolled Zr-4 alloy pipe will form bonding defects. The specific morphology is shown in Figure 5 (a). In the next process, the strain distribution of the tube billet containing bonding defects is uneven, which is due to the joint action of the axial tensile stress parallel to the extension direction of the tube and the radial compressive stress perpendicular to the inner wall of the tube. In the subsequent single-channel times when the rolling deformation of the pipe in the rotation of the groove diameter shrinkage under pressure, when the roller rotate to the position of the adhesive, tube wall metal flow under the force of inequality, which formed on the inner wall of the tube, the phenomenon of uneven distribution of strain, and centered on defects formed in the defect area local accumulation phenomenon, fold the early morphology formation, as shown in Figure5 (b) and (c).When the pipe continues to be rolled, the folded edge inside the pipe receives the action of the axial friction force exerted by the core head. Part of the folded edge of the pipe is worn and presents the irregular sawtooth morphology, thus forming the final morphology of the folded line, as shown in Figure 5 (d). The FEM model of Zr-4 alloy pipe folding is established, and the simulation results of the model are consistent with the actual production results, which can provide guidance for the optimization of Zr-4 alloy rolling process. As seen that the results and FEA model were an efficient quantitative tool to product guidance.

**Figure 5.** Typical morphology of the inner surface of Zr-4 finished pipe (a) Un-finished pipe (b) finished pipe

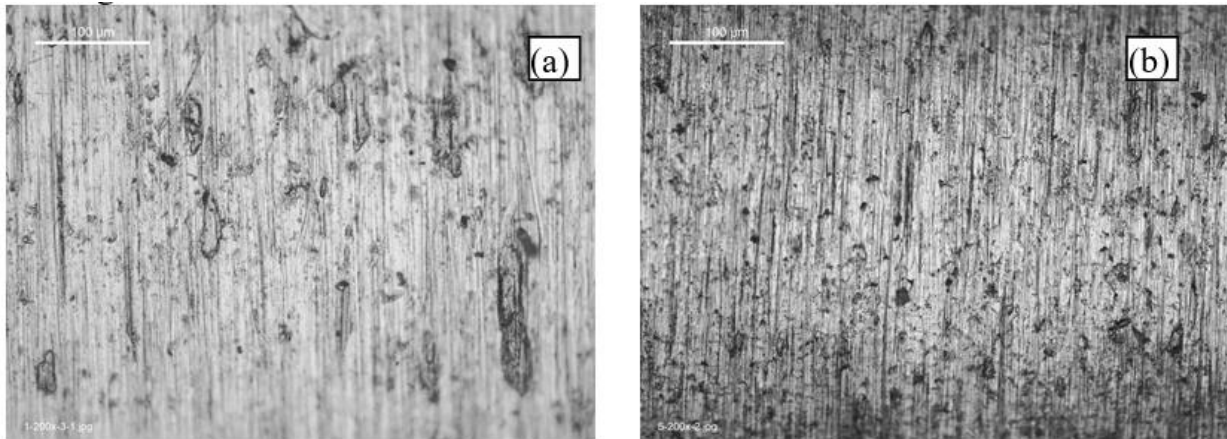
he metallographic images of the defect area transverse damage channel and the normal area are shown in Figure 6. As can be seen from Figure 6, when the magnification is 200X, there are obvious polishing lines in both the defect area and the normal area of the coated pipe. When the magnification is increased to 200X, the scratches caused by polishing on the pipe can be clearly seen. Contrast curve

signal area and normal area of metallographic photos as you can see, the defect display area have obvious indentation, and a normal areas with multiple small indentation, preliminary presumably cladding tube outer surface polishing scratches and a large number of polishing abrasive belt small particles into the indentation of the outer surface of the rough, appear in the process of ultrasonic inspection flaw signals.

**Figure 6.** Outer surface of sample 200X (a) on defect area (b) on normal area

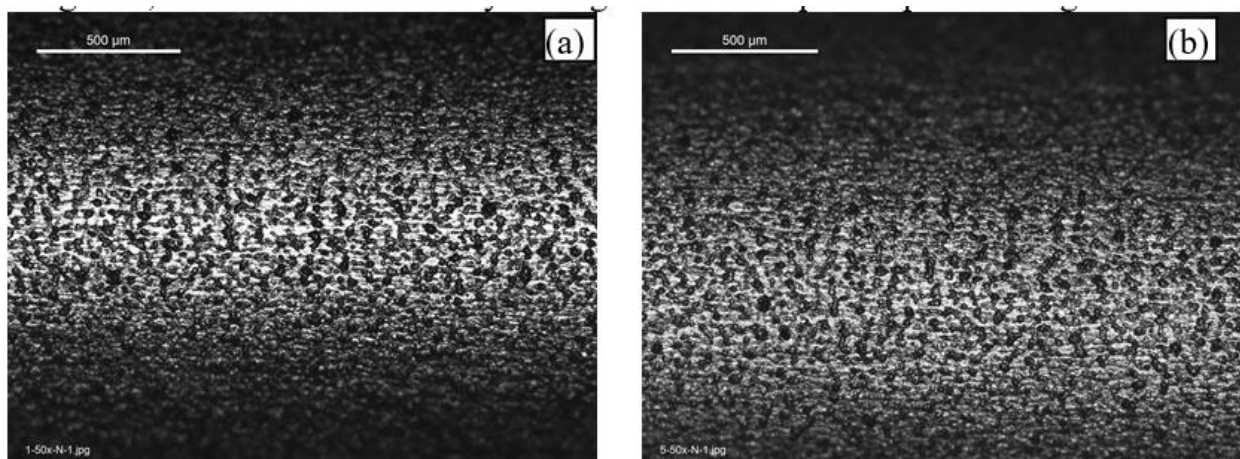
By comparing the 10X and 50X metallographic images of the inner surface (pickling state) of the defect signal area and the normal area, no significant difference was found between the two, so the influence of the inner pickling process on the defects of the cladding tube can be preliminarily discharged. Based on the fact that the defect display is mainly reflected in the transverse and longitudinal damage areas of the ultrasonic atlas, in order to more systematically compare the difference between the defect area and the normal area, the coating defect display area and the normal area are divided along the axial direction at the same time. The metallographic photo of the sample is shown in Figure 7. As can be seen from Figure 7, there is no significant difference between the axial profile of the defect display area and the normal area. This may be due to the shallow indentation caused by the outer polishing process on the surface of the cladding tube, which is not effectively distinguished in the profile photo in Figure 7.

**Figure 7.** Inter surface of sample 50X (a)Inter surface defect area (b)Inter surface on normal area

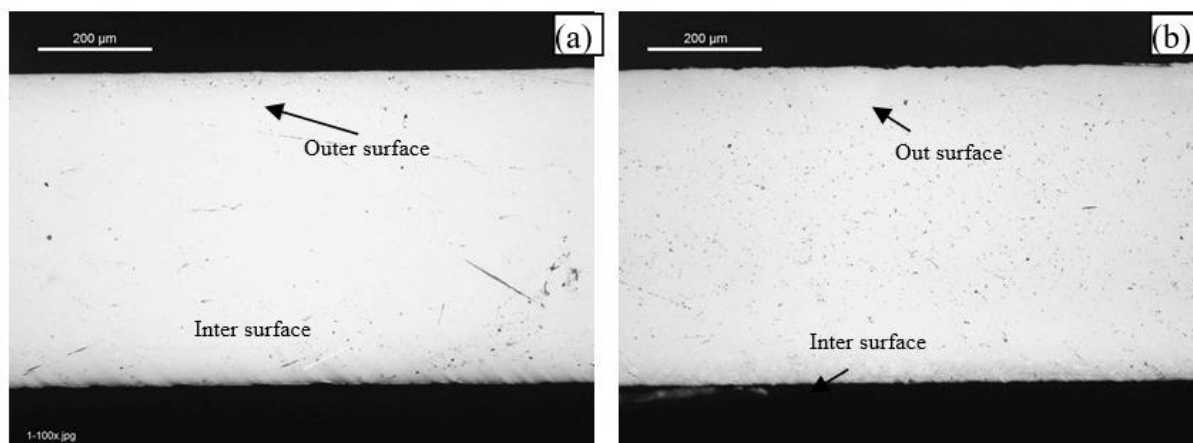
**Figure 8.** Profile sample 100X (a)defect area (b) normal area
