# Intelligent Fire Resistance Testing and Calculation of Precast Modular House by Computer Numerical Simulation

In this paper, through the fire resistance tests of 14 components and a full-scale flat-packed modular house, the fire resistance limits of the components under the standard fire curve and the performance of modular house entirety under real fire scene were studied. The experiment results showed that the fire resistance limits of the steel components cannot meet the relevant requirements of permanent buildings which are ruled in the code for fire protection design of buildings (GB 50016-2014) [10], since the cold-formed thin-walled structure was adopted in the modular houses. However, the fire resistance limits of the components with fire prevention measures could be greatly improved. In real fire scene, structural damage didn't occur under certain fire loads, which proved that flat-packed modular house could be applied in three-story buildings. The research results of this paper can provide references for the fire resistance design of light steel modular houses.

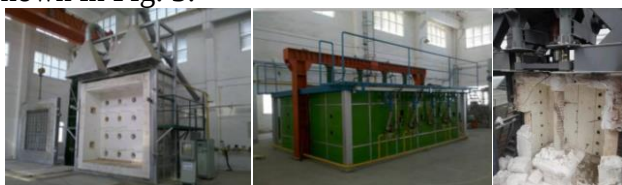
**Figure 3.** Test equipment

The fire resistances of walls were tested in a vertical fire test furnace, and the maximum post-fire size of the equipment was  $3.2\text{m} \times 3.2\text{m}$ . The horizontal components such as beams, floors, emergency stairs and ceilings were tested in a horizontal fire test furnace, whose post-fire size was  $3.0\text{m} \times 4.5\text{m}$  and up to  $4.8\text{m}$  for beams. The above equipment meets the requirements of GB UL EN BS ASTM standards. Columns were tested in a vertical component fire-resisting experimental furnace in the structural laboratory. The maximum vertical load is 500t, and the column length should be less than  $3.0\text{m}$ . The equipment is shown in Fig. 3.

(a) Vertical fire test furnace (b) Horizontal fire test furnace (c) Column fire test furnace

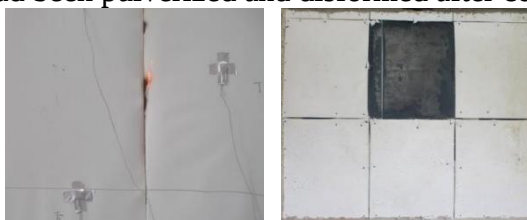
**Figure 4.** Firewall test

During the test, the fireproof board was connected to the wall by self-tapping nails. Before 55min, the initial section of the temperature rise curve of the non-fire surface was relatively flat. With the enlargement of the gaps caused by thermal deformations of fireproof boards, the temperature rose rapidly. During the whole process, the wall deformation rate increased continuously, and the maximum deformation at the geometric center was 64 mm. At 99min, the highest temperature of the non-fire surface of the specimen increased by  $186.2^{\circ}\text{C}$ , exceeding the standard limit, and the specimen lost the heat insulation. At 100min, the flame appeared on the back of the wall and lasted more than 10s, therefore the specimen lost the integrity (Fig. 4a).

After the firewall test, one piece of the fireproof boards fell off (Fig. 4b), the gaps between the fireproof boards were obvious, and the screws of the fixed fireproof boards fell off or broke. The shedding fire-proof boards had been pulverized and deformed after cooling.

(a) Continuous flame on the back at 100min (b) Fire side of specimen after test

4) While the sandwich panel wall is wrapped with fireproof boards, the fixation of the fireproof boards and the sealing of the gaps should be strengthened. The joint materials should have good expansion and fire resistance. It is maybe positive on extending the fire resistance limit of walls while the fireproof board is used as the core layer and not directly heated. The air layer between the double wall boards has positive effect on delaying heating.

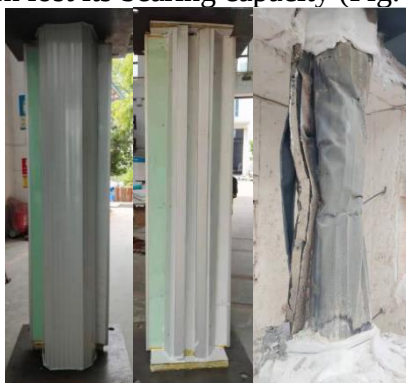
**Figure 5.** Composite column test

The structure of composite column was designed to fully simulate the actual situation in the emergency project: the side in the corridor was surrounded by 0.426mm iron wrapping (Fig. 5a), and the other side simulated the spatial occlusion relationship between the interior walls, the columns and the iron wrappings (Fig. 5b). The wall sections were wrapped by aluminum alloy, and the gaps between the walls were blocked by rock wool sandwich plates. At 103min19s, the maximum axial compression deformation was 25.635mm, and the maximum axial compression deformation rate was 23.495mm/min. Thus the specimen lost its bearing capacity (Fig. 5c).

(a) Side in the corridor(before test) (b) Side in the room(before test) (c) Column after test

5) The fire resistance limit time of the composite column is much larger than that of a single column, which shows that the fire protection effect of walls and iron wrappings on L-shaped steel columns is obvious.

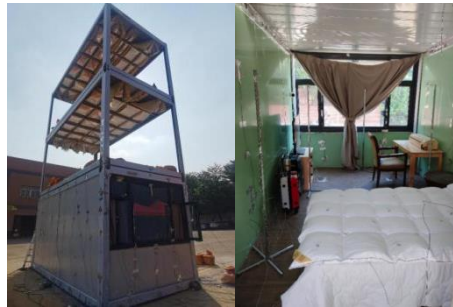
**Figure 11.** Flat-packed modular houses before test

During the test, the weather was sunny. At the beginning of the test, the ambient temperature was 30.5°C, the humidity was 50%, the atmospheric pressure was 100.7kPa, and there was no wind (Fig. 11).

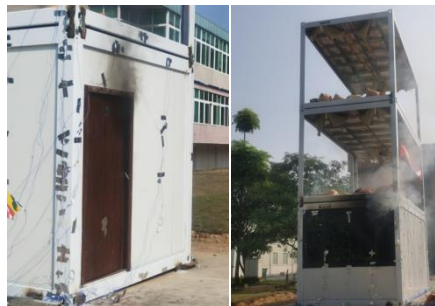
**Figure 13.** 6min50s and 7min34s after start-up

| Time<br>(hh:mm:ss) | Process record |
|---|---|
| 00:06:50 | Black smoke began to emerge at the door gap. |
| 00:07:34 | Black smoke emerged from the corners of the window and the gaps between the wallboard and top beams. |

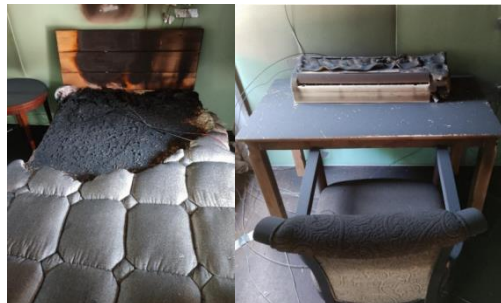
**Figure 14.** Furniture after test

4) After the test, a 1.2m×1.2m range combustion carbonization was found on the mattress. Smoke alarms arranged on the ceiling was burned down to the ground. The plastic shell of the air conditioning was partial melted as shown in Fig. 14. No abnormal was found on glasses of the window. Indoor tables, chairs, curtains, television and the luggage were not burned.

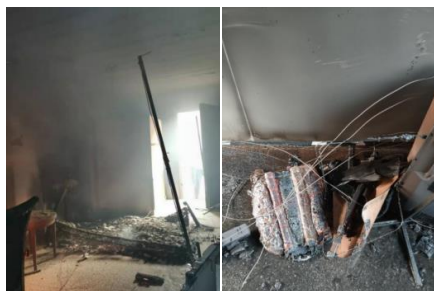
**Figure 15.** Bed and luggage after test

| Time<br>(hh:mm:ss) | Process record |
|---|---|
| 02:01:19 | The door and the window were opened to ventilate and exhaust smoke.<br>The bed, bedding articles, luggage, curtains, air conditioning were almost burned out and the window was not broken as shown in Fig. 15. |
