# Comparison and Selection of Repair and Reinforcement Plans for Songkou Bridge

**Abstract.** Under the long-term action of heavy and overloaded vehicles exceeding the designed load level, the Songkou Bridge suffered serious damage. After on-site inspection, the cause analysis of the main diseases is carried out, and the corresponding reinforcement and reconstruction plan is formed. The reconstruction of the bridge needs to increase the width of the bridge deck and increase the load level by rebuilding the upper structure. Finally, three schemes are formed for comparison and selection, and the optimal scheme is selected to renovate the bridge to meet the structural safety requirements and traffic requirements.

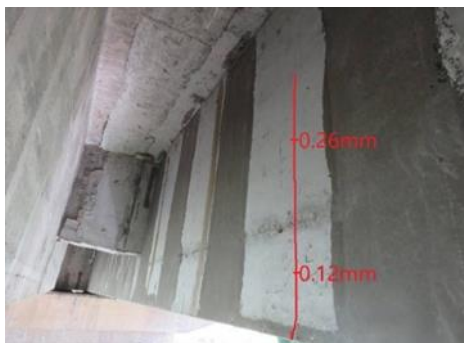
(a) Vertical cracks in the web of the beam

Figure 2. Schematic diagram of the main cracks of the main beam

After inspection, it was found that there were 1499 vertical and oblique cracks in the web of the main beam. The total length of the cracks reached 583.14m. Among them, 3 cracks in the web of 1-6# and 4-2# T beams exceeded the limit, and the width of the over-limit cracks was 0.26~ 0.4mm; There are 352 transverse cracks in the bottom plate of the main beam, and the total length of the cracks reaches 63.36m. Among them, one crack at the bottom of 6-1#T beam exceeds the limit, and the width of the excess crack is 0.29mm.

Secondly, the large number of vertical cracks that did not exceed the standard in the main beam web are shrinkage cracks, which are mainly due to the large difference in age between the newly poured T beam and the original T beam, and the shrinkage of the newly poured concrete is constrained by the old beam body. This results in cracks in the weak web.

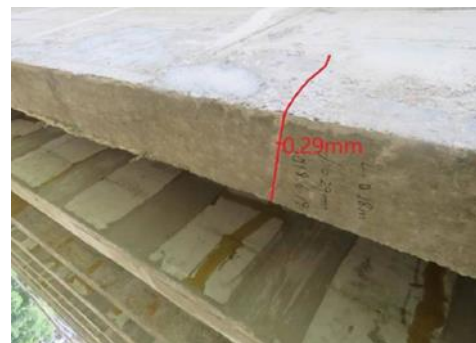
(b) Transverse cracks in the beam bottom plate

First of all, there are transverse bending cracks at the bottom of the main beam. Most of the width of the transverse cracks at the bottom of the beam is within the limit. Only one crack at the bottom of the 6-1#T beam has a width of 0.29mm, which is mainly due to the load caused by heavy vehicles and other reasons. The effect is greater than the design load-bearing capacity of the beam, causing cracks to exceed the limit.
