Application of Magnetic Flux Leakage Internal Detection Technology in Evaluation and Analysis of Crude Oil Pipeline Corrosion

Abstract: There are many abnormal points in the magnetic flux leakage internal inspection results of a crude oil pipeline. For 20 of the more serious metal loss anomalies Internal corrosion evaluation standard specification, corrosion evaluation and pressure analysis. The results of corrosion evaluation and pressure analysis are taken as the basis for theoretical screening, and the final selection is preferred. The excavation verification and defect repair were carried out at 3 abnormal points of internal inspection. The accuracy of magnetic flux leakage internal detection results is verified through excavation verification, which proves the magnetic flux leakage internal detection. The measurement technology can play a role in the evaluation and analysis of pipeline corrosion.

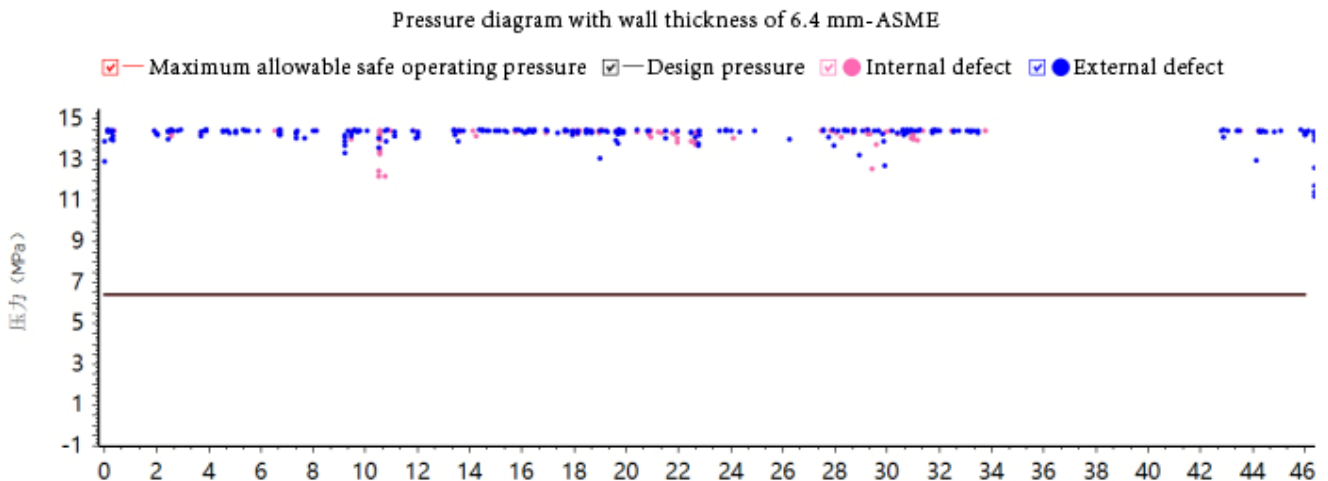
Figure 3. Metal Loss Pressure Chart

The design pressure of some pipe sections is 6.4 MPa, the maximum allowable safe operating pressure MAOP is 6.4 MPa, the design coefficient is 0.72, and the metal loss pressure diagram with a wall thickness of 6.4 mm is shown in Figure 3.

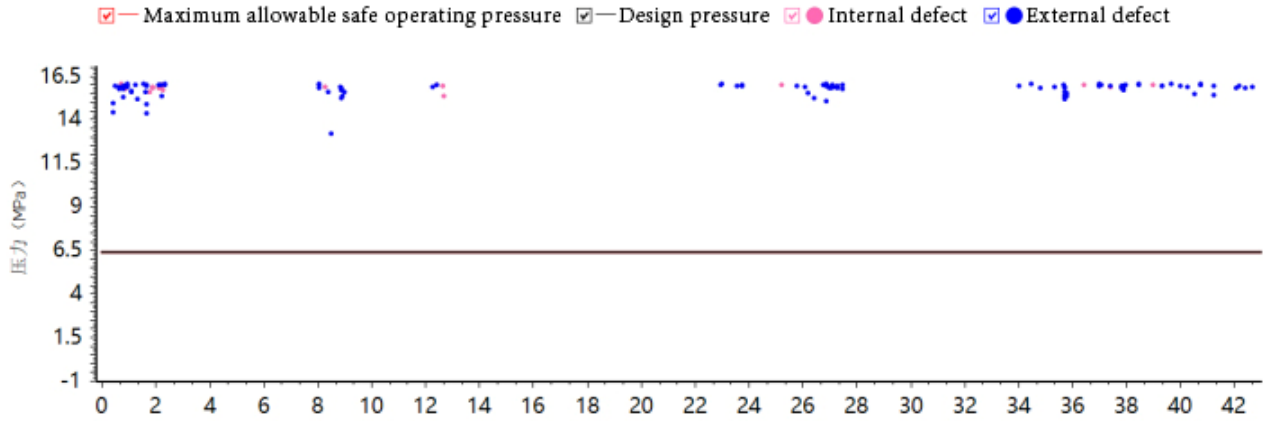
Figure 4. Metal Loss Pressure Chart

The design pressure of some pipe sections is 6.4 MPa, the maximum allowable safe operating pressure MAOP is 6.4 MPa, the design coefficient is 0.72, and the metal loss

pressure diagram with a wall thickness of 7.1 mm is shown in Figure 4.

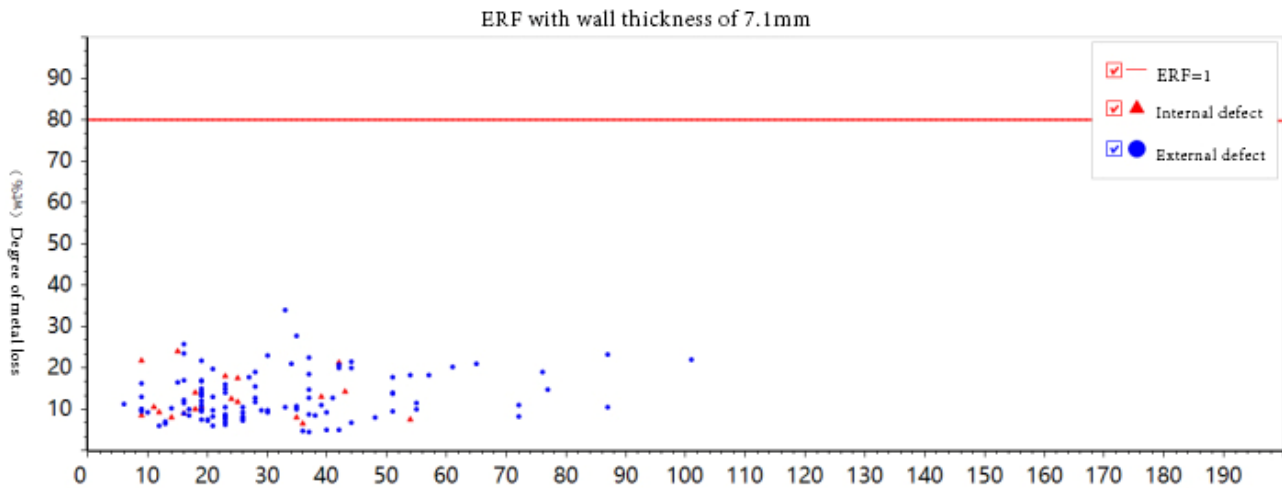
Figure 6. ERF Chart of Metal Loss

The design pressure of some pipe sections is 6.4 MPa, the maximum allowable safe operating pressure MAOP is 6.4 MPa, the design coefficient is 0.72, and the metal loss

pressure diagram with a wall thickness of 7.1 mm is shown in Figure 6.

The metal loss ERF evaluation curve shows that the ERF values are less than 1, and the remaining 605 defects do not need immediate repair. The statistical table of metal loss in different ERF ranges is shown in Table 4.
