Finite element analysis of reinforcement for gas insulated switchgear

Abstract. Considering the burgeoning requirement for reinforcing gas-insulated metal-enclosed switchgear, a three-dimensional elastic-plastic finite element model was established to examine the stress distribution before and after reinforcement. The results showed that, under an internal pressure of 3.8 MPa, the maximum stress of the defective sample surpassed the yield strength of the material, leading to its destruction. On the other hand, the maximum stress value of the reinforced sample, with a gel and a reinforcing plate, decreased to 145 MPa and was lower than the yield strength of the material. Moreover, the results of the hydrostatic test further demonstrated that the gel was effective in reducing the stress concentration at the defect within a certain range. In particular, the results indicated that the gel was capable of decreasing the maximum stress value by 33 MPa, thereby safeguarding the structural integrity of the switchgear.

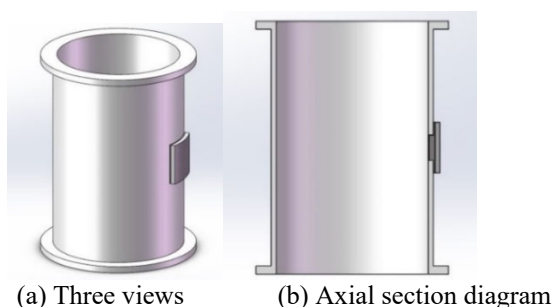
Figure 1. Schematic diagram of GIS pipeline defective components

(c) Radial section diagram

Figure 2. Schematic diagram of GIS pipeline reinforcement components

The GJSJ-300 pipe fitting press test machine was employed to conduct the experiment. The specifications of the pipe fitting were 320 millimeters in outer diameter, 300 millimeters in inner diameter, 500 millimeters in length and 16 millimeters in flange thickness. The material of the pipe was 6063 aluminum alloy. The damaged area of the defective sample had a rectangular structure; its defect size was 5 centimeters by 5 centimeters and its deepest surface size measured 9 millimeters, located in the middle. The reinforcing sample (which contained defects on the pipe) had a reinforcing plate measuring 10 centimeters by 10 centimeters by 6 millimeters, and the material used was 304 stainless steel. Prior to the reinforcement repair, the outer surface of the GIS pipe shell was polished, and then glue was used to fill the gap between the reinforcement plate and the pipe wall. Figure 1 and 2 depict the schematic diagram of the conformation member and the reinforcing member respectively. Finally, Table 1 outlines the mechanical properties of the aluminum alloy, gel, and stainless steel materials.

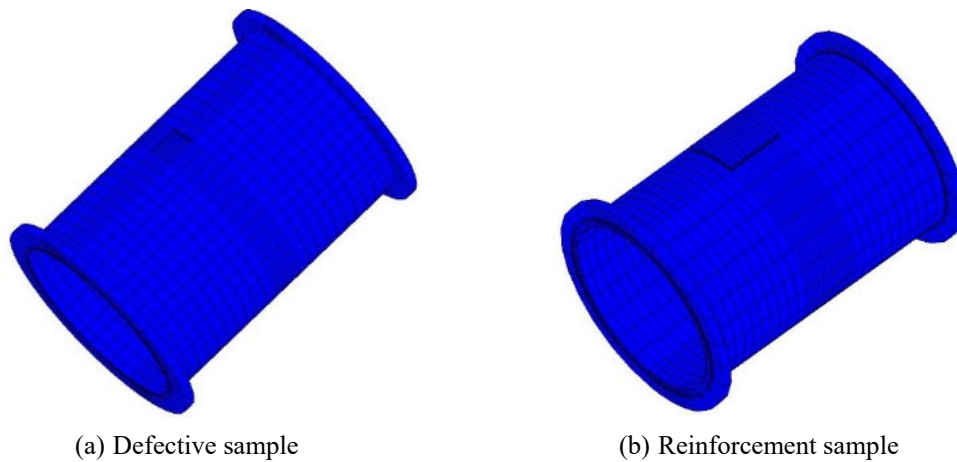
Figure 3. Geometric model meshing

According to the size of the geometrical model of the shell-reinforced structure, the geometrical representation was established, and a non-uniform finite element mesh was created. Taking into account both the accuracy and efficiency of the computation, the mesh division at the notch, reinforcement area, and adjacent areas was densified; in contrast, the mesh at regions far from the weld was sparse, as pictured in Figure 3.

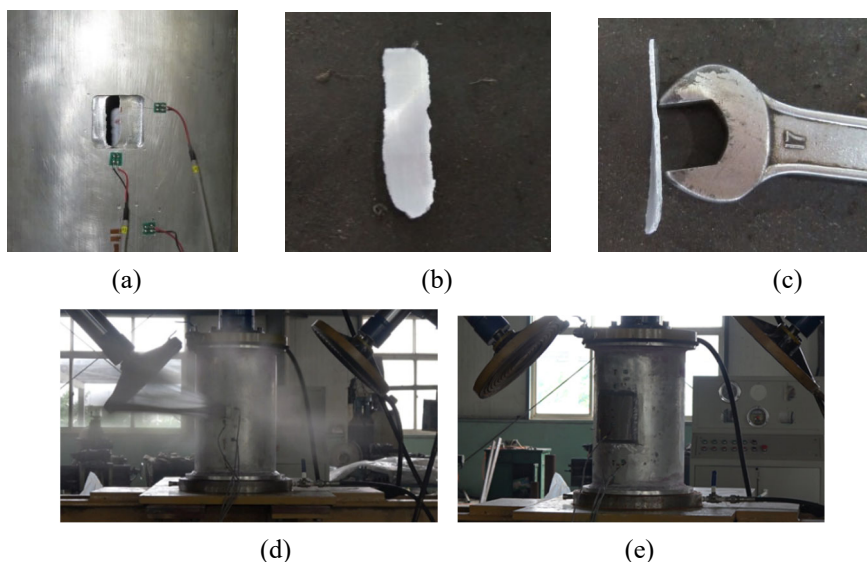
Figure 4. Test process diagram of GIS pipeline defect components and reinforcement components

Firstly, the experiment was conducted on a pipe with defects of 5 cm x 5 cm and the deepest surface defect of 9 mm. Upon applying pressure at 3.8 MPa, the pipeline was damaged, as depicted in Figure 4a; a 1 cm wafer flew out, as depicted in Figure 4b and c. Subsequently, using gel reinforcement, a reinforcing plate of 10 cm x 10 cm was employed. Following the reinforcement, the pressure test remained intact at 7 MPa. When the pressure was further increased, the test was discontinued due to the failure of the gasket, as shown in Figure 4d and e.
